JANUARY, 1904.

The Locomotive

PUBLISHED BY THE HARTFORD STEAM BOILER INSPECTION AND INSURANCE COMPANY.

Vol. XXV. HARTFORD, CONN., JANUARY, 1904. No. 1.

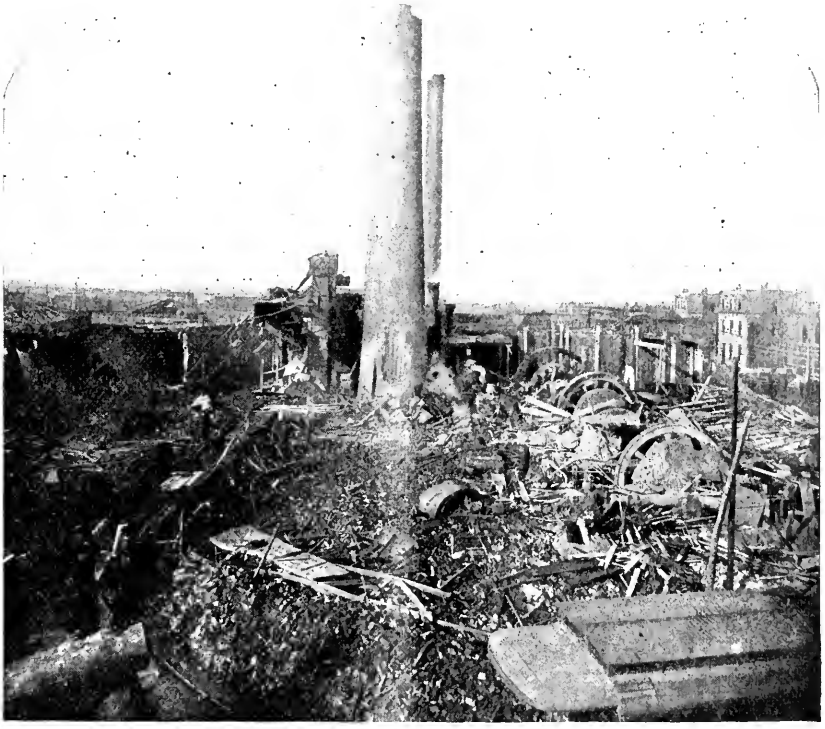
A terrible boiler explosion occurred, on the 21st day of last December, in the Geyer Avenue plant of the St. Louis Traction Company, at St. Louis, Mo. Seven water-tube boilers exploded simultaneously, six of them being blown to pieces, while the seventh had fifty-two of its tubes blown out, and was itself

FIG. 1. — GENERAL VIEW OF THE RUINED PLANT.

thrown into the street. Water-tube boilers are often called "safety boilers"; but this designation is manifestly undeserved, because in the present case there were eight men killed and twenty-one others injured. The explosion was equally disastrous, if judged by the extent of the damage done to property, for the buildings and machinery that were destroyed covered an area of something like thirty thousand square feet, and were valued at about $75,000.

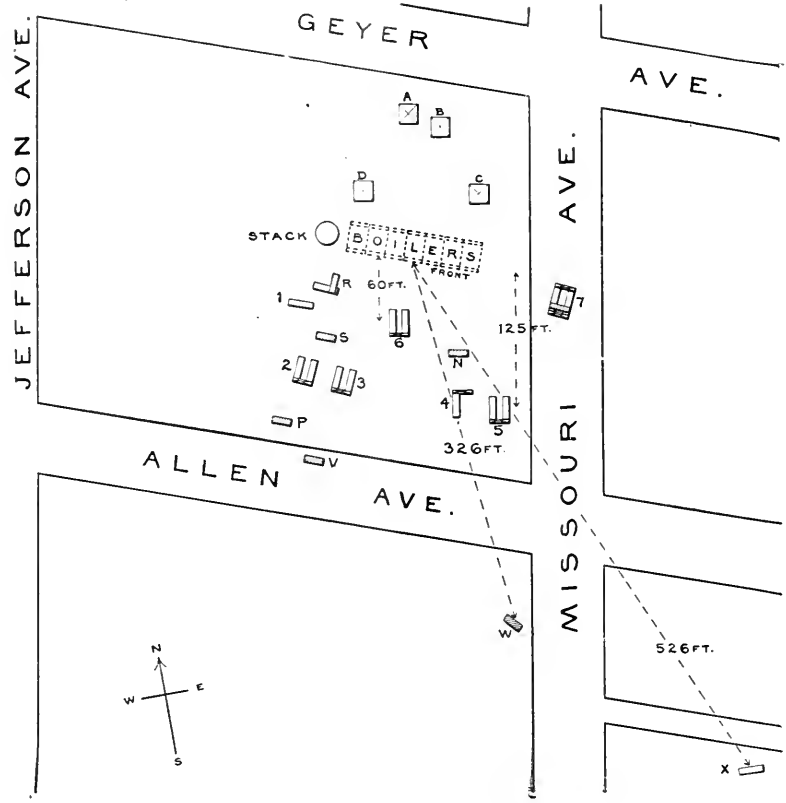
FIG. 2. — SHOWING THE DISTRIBUTION OF THE FRAGMENTS.

The force of the explosion was very great. The boilers, fronts, piping, and attachments generally were broken, and the fragments were scattered over a large area. The windows and doors in houses surrounding the power house were smashed, the adjoining car shed was partly wrecked, and a number of street cars were demolished. It is a remarkable fact that all the rear water-legs went north, while the drums and front water-legs went south. It is also remarkable that no drum was ruptured through the longitudinal joints. In Fig. 2 we have indicated the distribution of most of the pieces after the accident. The rear water-legs are represented by the rectangles A to D, inclusive. The stay-bolting of these legs held remarkably well, no broken stay-bolts being found, and only a

few having pulled through the sheets. The rear heads remained with the rear legs, the lines of rupture being through the inside girth leg joint, across the short horizontal leg joint, through the solid sheet, and then either following the head joint (as in most cases), or, as in a couple of instances, tearing through the manhole. Of boilers Nos. 2, 3, 5, and 6, two drums and the front leg remained together; of No. 4, the front leg and one drum remained together, the other drum being found at the point marked "X" in Fig. 2, at a distance of 526 feet from its original position. All the elements of boiler No. 1 (i. e., the legs, drums, steam drum, etc.), were separated from one another. Boiler No. 7, as already stated, remained practically intact, save for the blowing out of fifty-two of its tubes. Three tubes remained in boiler No. 4, and a like number in boiler No. 5; but from all the other boilers all the tubes were blown out. Most of the tubes

were found where the boilers originally stood. Most of the drums showed a V-shaped tear where the drum pulled away from the steam-drum leg. The steam drums were scattered about as shown by the cross-hatched rectangles R, S, N, P, V, W, in Fig. 2. One tube was found ruptured, it having opened out flat for a length of about six feet. (This tube is shown somewhat unsatisfactorily in Fig. 3, where it is indicated by the white cross.) A few tubes were found to be slightly bulged, but not ruptured. Many of the tubes were thin, one which was taken from boiler No. 4 measuring only 0.034 in. in thickness, an inch and a half from the end which was expanded into the front leg. The accompanying photoengravings will give an idea of the havoc which was wrought.

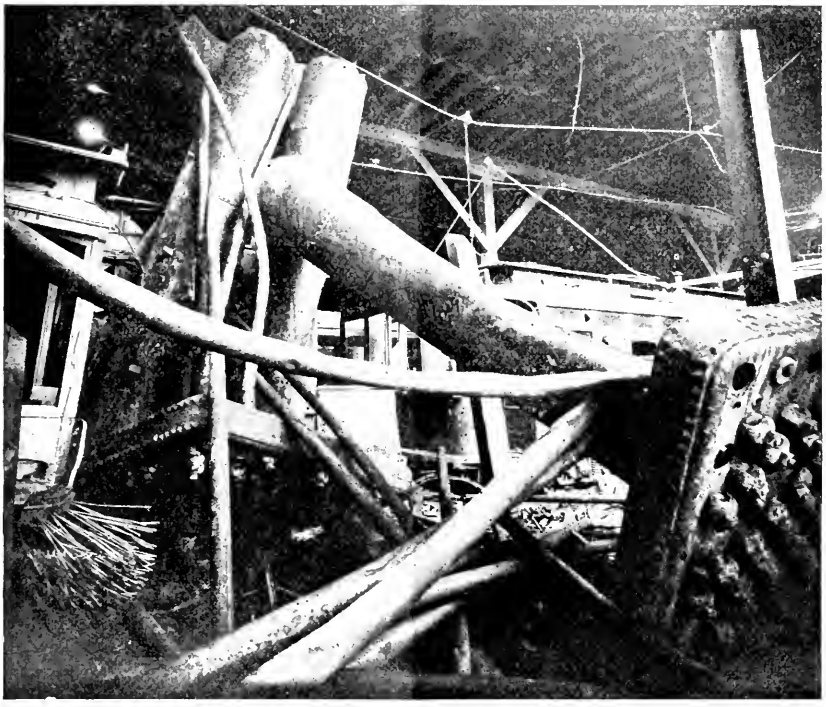
FIG. 4. — SHOWING THE RUINS OF BOILERS NOS. 4 AND 5.

The boiler showed signs of distress under the exacting service to which it was subjected, and possibly a leakage occurred at the tube-ends; for it is known that a telephone message was sent to the central station, to throw some of the load off of this plant. The initial rupture, in the opinion of the expert who viewed the ruins on our behalf, consisted in the failure of the tube shown by the white cross in Fig. 2; this tube evidently having opened out flat for a length of about six feet. There is nothing unusual in a failure of this sort, for tubes in water-tube boilers rupture in this manner very frequently. Sometimes the rupture is due to a defective weld, but it is oftener due to the presence of scale in the tube, the scale keeping the water away from the tube, and thereby allowing overheating to occur, rupture following as a natural consequence. Under the severe conditions mentioned above, the rupture of this one tube would undoubtedly be sufficient to precipitate the explosion which actually occurred. The reaction of the steam and water escaping from this one tube would suffice, in all probability, to tear other tubes out of the tube-sheets; and the reaction on the water-legs of the steam and water escaping from the openings so made would tend to spread the legs apart. The front leg, however, rested solidly upon the brickwork, while the rear leg had a roller under it, and was therefore more free to move. Or, it may have been that as the boiler settled on the mass of brick (the tubes sloping to the rear), the rear ends were torn out of the rear legs first, and the reaction of the water and steam flowing out of the tube holes caused the rear legs to fly backwards, or towards the north.

It appears likely that the complete destruction of boiler No. 1 caused the partial destruction of the brickwork around No. 2, and as No. 2 settled on its mass of brickwork its lower ends were pulled out of the rear water-leg, and the leg was blown northward; and so on down the line, the available energy decreasing all the time, as shown by the fact that No. 7 was only slightly damaged.

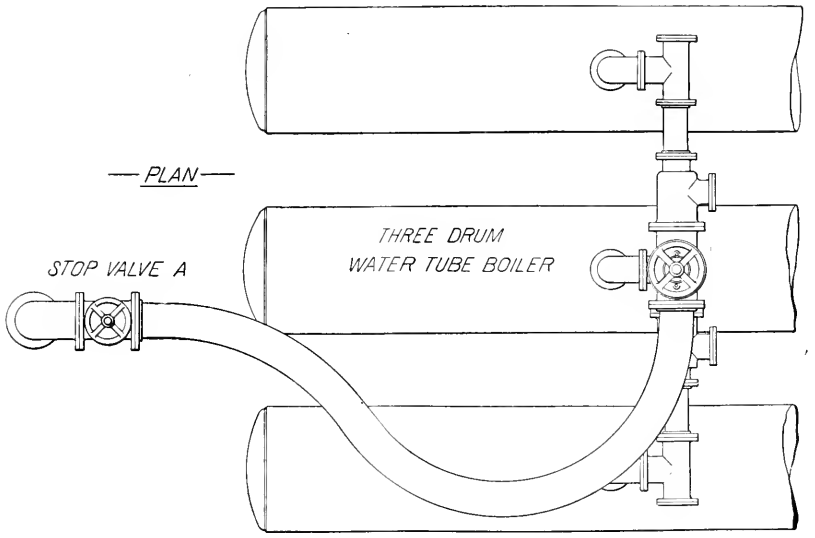
FIG. 1.

We have frequently, in the pages of THE LOCOMOTIVE, called attention to the danger of putting in steam pipes in such a way that they can act as traps, and collect any considerable quantity of water of condensation. When steam is turned into a pipe containing entrapped water, it is an unfortunately common experience that the entering steam causes the water to surge about in some way that is not entirely understood, so that it is often thrown against the fittings with such violence as to cause some part of the pipe line, or its connections, to break. The

mediately upon the top of this boiler there was a safety stop valve, *B*, which was designed to close automatically in case of any abnormally violent rush of steam through the feeder to which it was attached. This automatic valve was closed at the time of the accident, and another stop valve, *A*, situated on the same feeder where it entered the boiler, had also been closed. The boiler had been out of service for a time, but pressure had been raised upon it again, and it was about to be "cut in" with the other boilers in the battery. For this purpose the stop valve *A* was opened, the intention being to open the automatic valve, *B*, immediately afterwards. It is probable that, owing to leakage through one or the

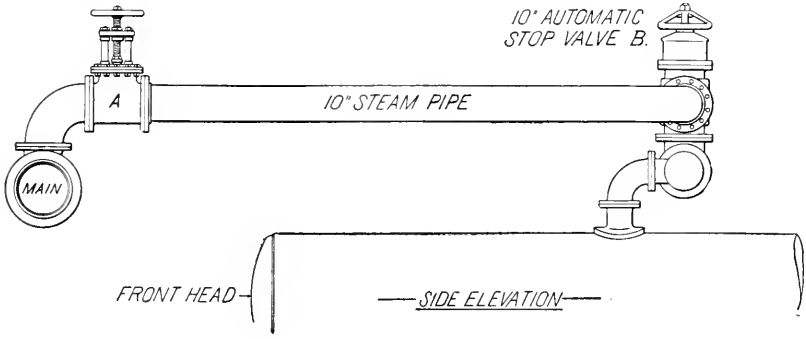
FIG. 2.

other of the two valves, there had been an accumulation of water in the space between these valves; the entering steam causing this water to surge around through the curved pipe in such a way as to throw it violently against the automatic valve. At all events, the stop valve, *A*, was hardly opened when a section of the casing of the automatic valve was knocked out, as indicated by the shaded area in Fig. 3; several men who were standing near by being also scalded. Where two valves are used on a steam pipe in this manner, provision should always be made for draining the space between them before either valve is opened; and when one of the valves is opened, it should be opened very slowly indeed. Furthermore,

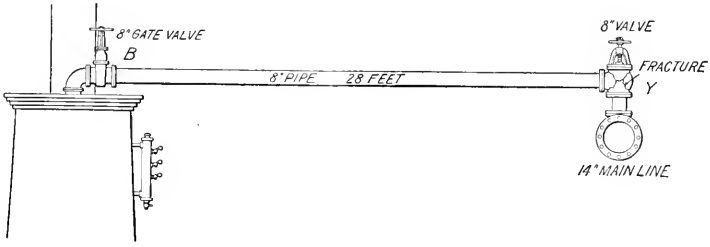
FIG. 4.

Fig. 4 illustrates another case, quite similar in its general aspects to the one described above. The boiler was here of the vertical water-tube type, and there was a gate valve in the branch pipe near the boiler, as well as a globe angle valve where the branch pipe entered the large main. From the circumstances attending the accident here under consideration, and from the close similiarity between it and other accidents in which water-hammer was undoubtedly the chief and perhaps the sole factor in determining the destruction, we are confident that this was also a case of water-hammer action. There had undoubtedly been leakage through one or both of the valves shown, so that the steam pipe had become more or less filled with water. At any rate, when the valve *B* was opened, the casing of the valve *Y* was almost immediately fractured, being broken into several pieces. It will be understood that in an accident of this kind it is often very difficult indeed to prove, beyond further argument, just what the cause was. In the present case, it has been pointed out that the valve *B*, being a gate valve, would naturally not be opened very rapidly; and it has been argued that this

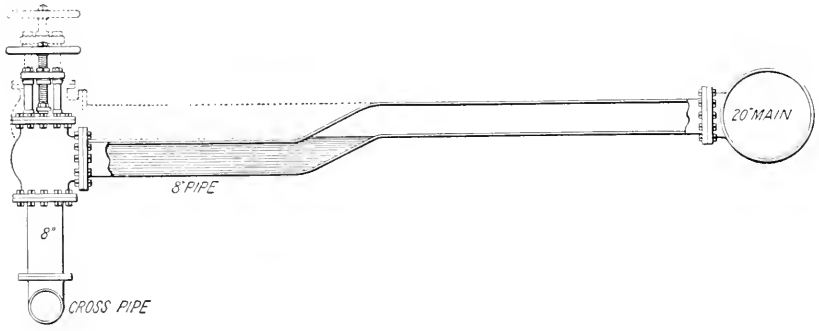
FIG. 5.

In Fig. 5 we illustrate another accident, in which water-hammer was more evidently the cause of the trouble. In this case, the feeder pipe from the boiler to the main was bent, in order to clear a fore-and-aft line of pipe. There was only one valve, in this instance, between the main pipe and the boiler; but it is easy to see that with the boiler out of service, and steam in the main pipe, there must be condensation in the bent feeder, and the water of condensation must collect, in large measure, in the lowest part of the feeder, near the stop valve. Some changes had been made in the steam plant where this accident occurred, and the valve was being opened for the first time. We are informed that two men were engaged in opening the valve, from which we infer that it may not have been found to work entirely satisfactorily. We are further informed that there was a difference in pressure of 30 pounds between the boiler and the steam main, the pressure in the main being 150 lbs., and that in the boiler 120 lbs.

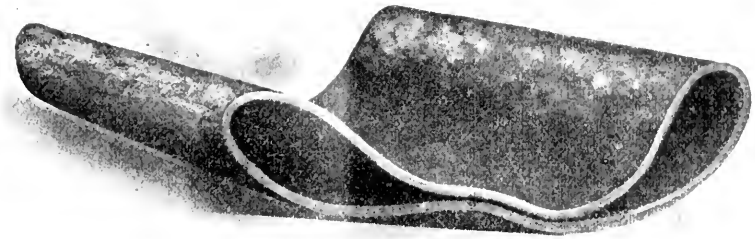
The reality of the danger from power tube cleaners is sufficiently illustrated by Figs. 1, 2, and 3, which are taken from actual specimens removed from a boiler upon which a power cleaner had been used. The particular cleaner that was employed in this case is one that hammers against the inside of the tube of a fire-tube boiler, the jar that is thereby communicated to the tube being supposed to rattle the scale off from the outside of the tube. In the instance now under discussion, two boilers of a certain plant had been cleaned in this way, and when they were again put in service seven of the tubes collapsed in one of the boilers when the pressure reached 90 pounds. The inspector of the Hartford Steam Boiler Inspection and Insurance Company was summoned at once, and upon visiting the plant he found that in addition to the seven tubes which had collapsed four others were strongly oval in shape, so that they had to be removed. Fig. 1 shows a portion of one of the collapsed tubes, precisely as it was removed from the boiler; the flattened part extending to within nine inches of the end of the tube, or over the exact distance traversed by the cleaner. Fig. 2 is a photoengraving of a section of one of the other tubes, which had become oval from the action of the cleaner, but which had not collapsed. The cause of the distortion is plainly indicated in this engraving. The cleaner, instead of being constantly rotated and moved along the length of the tube, had been allowed to remain in one position for a short time, so that the hammer had pounded against the tube in one spot, which is indicated by the bright area on

FIG. 1.—SECTION OF A TUBE COLLAPSED BY THE ACTION OF A TUBE CLEANER.

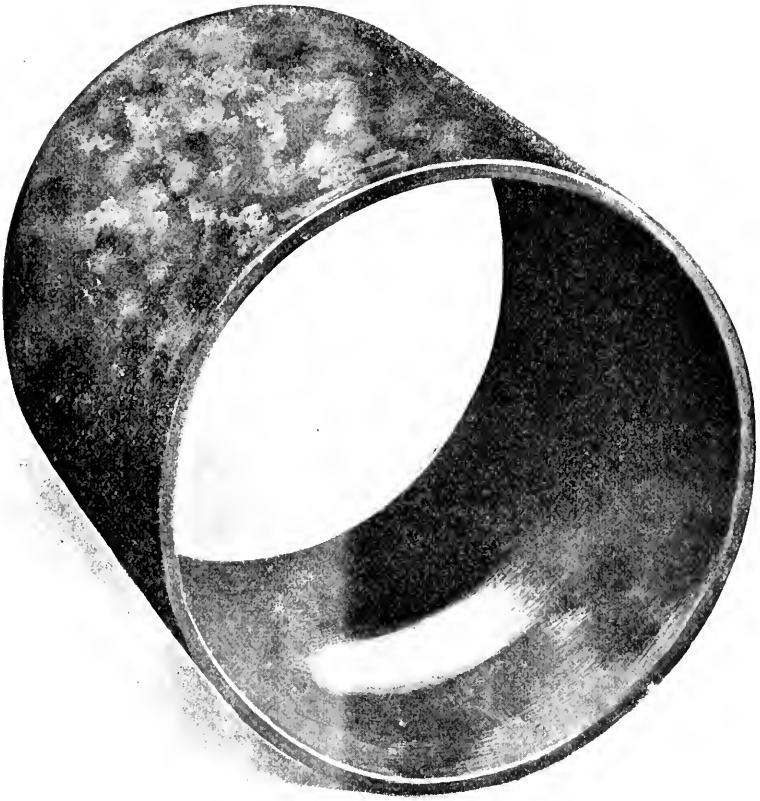
FIG. 2.—SECTION OF A TUBE RENDERED OVAL BY THE ACTION OF A TUBE CLEANER

the inside of the tube. The result was, that the tube was forced out into an oval shape, the greatest bulge coming opposite the bright spot. The actual deformation of the tube not being very evident to the eye in Fig 2, we present, in Fig. 3, an outline cut that exhibits it more clearly. The black outline in this cut was derived by placing the section of tube shown in Fig. 2 endwise against a sheet of paper, and drawing its inner and outer contours by a pencil; the space between the two lines so obtained being then filled in with ink, to represent the thickness of the tube. The actual, deformed contour being recorded in this way, dotted circles were next drawn, to show the original form from which the tube had been distorted by the action of the hammer. It is only fair to add that in this case micrometric measurements of the thickness of the affected tubes showed that they had been slightly thinned by the wear incident to ordinary use. The thinning was in no case great enough to render the tubes unserviceable, however, nor was it greater than would be found in the general run of boilers that have been a few years in service.

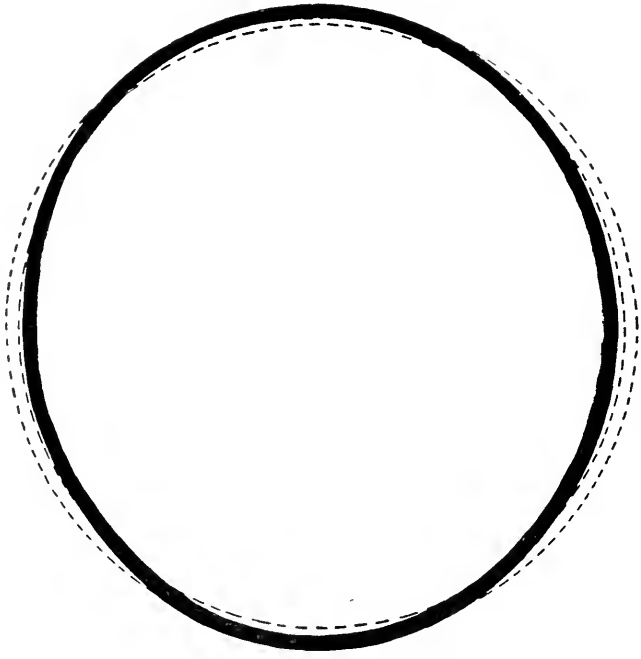
FIG. 3.— CROSS SECTION OF THE TUBE SHOWN IN FIG. 2.

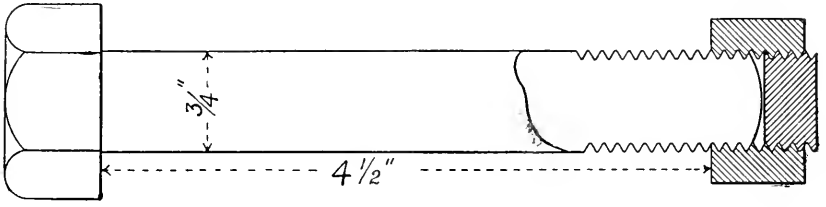
The illustrations that we present in connection with this article show very clearly that a boiler inspector needs to be exceedingly careful in passing judgment even upon new work. The bolt which is shown in Fig. 1 is one of several which were ordered removed from a new system of piping erected in a large steam plant, subject to examination and approval by an inspector of the Hartford Steam Boiler Inspection and Insurance Company. These bolts were used to join pipe flanges, and it was found that quite a number of them were too short, so that it was impossible to screw up the nuts upon them sufficiently to make the bolts enter more than from one-half to two thirds of their depth. When this defect was observed by our inspector, and notice of it was given to the contractors, a workman was sent to replace the short bolts with others of proper length. The piping ran across the upper part of the boiler room, and the air about it was exceedingly hot and uncomfortable, so that the task of replacing the bolts was a very unpleasant one. The workman bought the required number of

FIG. 1. — SHOWING "STUB END" OF BOLT IN POSITION.

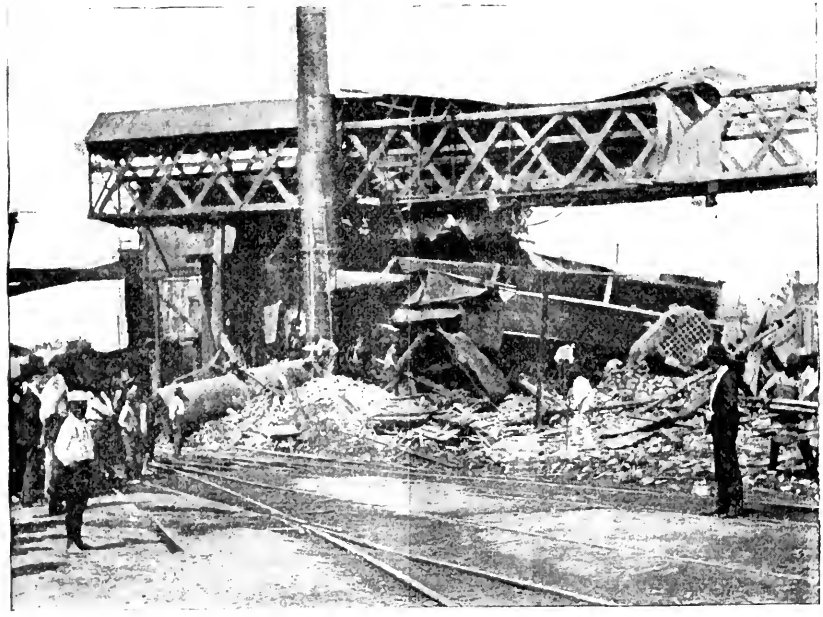
We present, herewith, three photographic views illustrating a recent boiler explosion in an ice factory. The boiler house contained four horizontal tubular boilers, set side by side, the one which exploded being the third, counting from the left hand end. It was 60 in. in diameter and 19 ft. 3 in. long, with 56 four-

FIG. 1. — GENERAL VIEW OF RUINS.

inch tubes, 18 ft. long. The shell was 11/32 in. in thickness. The initial rupture took place in the center course of the boiler, along the horizontal joint, each course being composed of a single plate. After the explosion, unmistakable evidence could be seen of an old fracture, which lay between the rivet holes and the edge of the lap of the joint, and which extended along the joint for a dis-

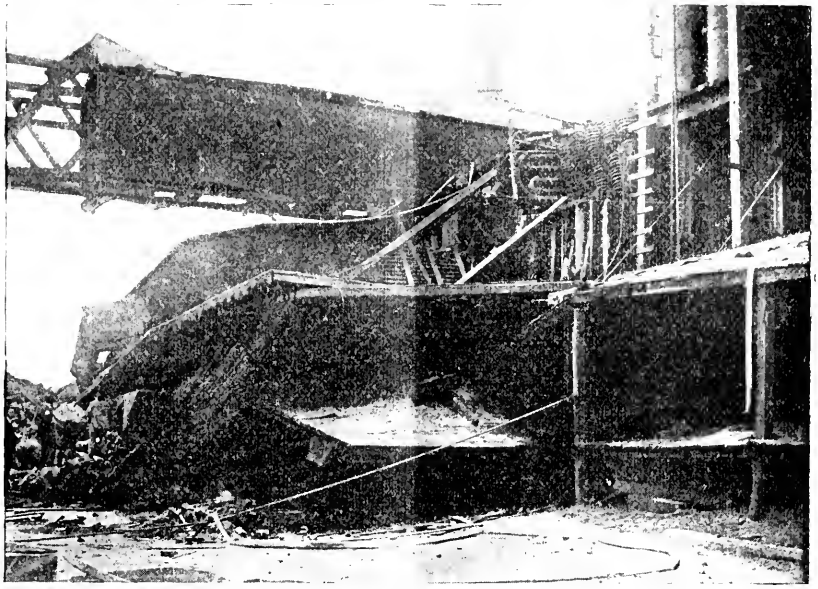
FIG. 2. — GENERAL VIEW OF RUINS.

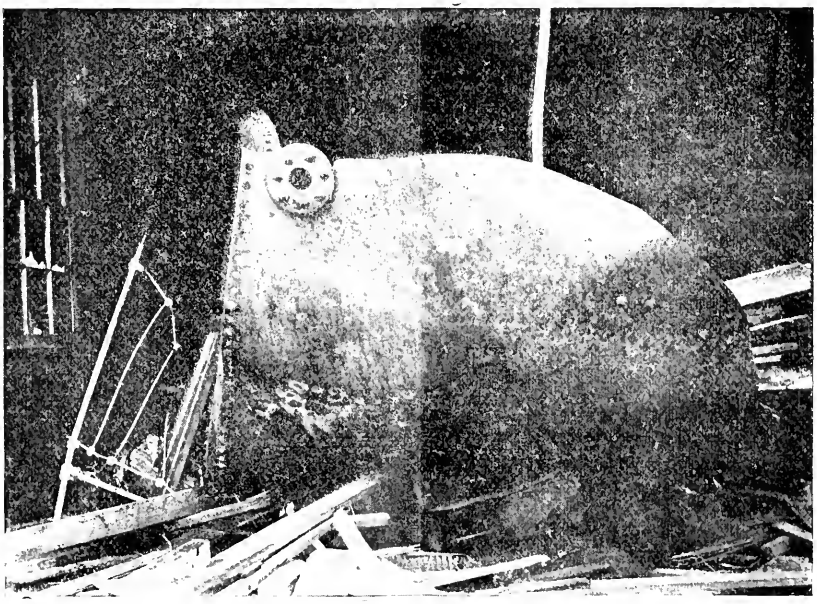
FIG. 3. — PORTION OF REAR SHEET OF BOILER.

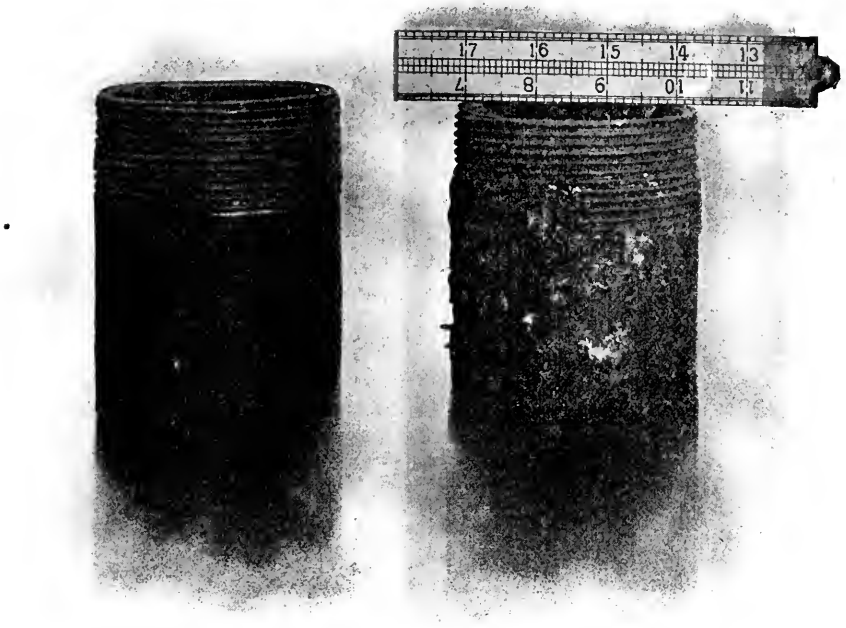
FIG. 6. — THREE-INCH PIPES. (THE ONE ON THE RIGHT COULD BE MADE UP ONLY SIX THREADS. THE OTHER WAS STANDARD, OR NEARLY SO.)

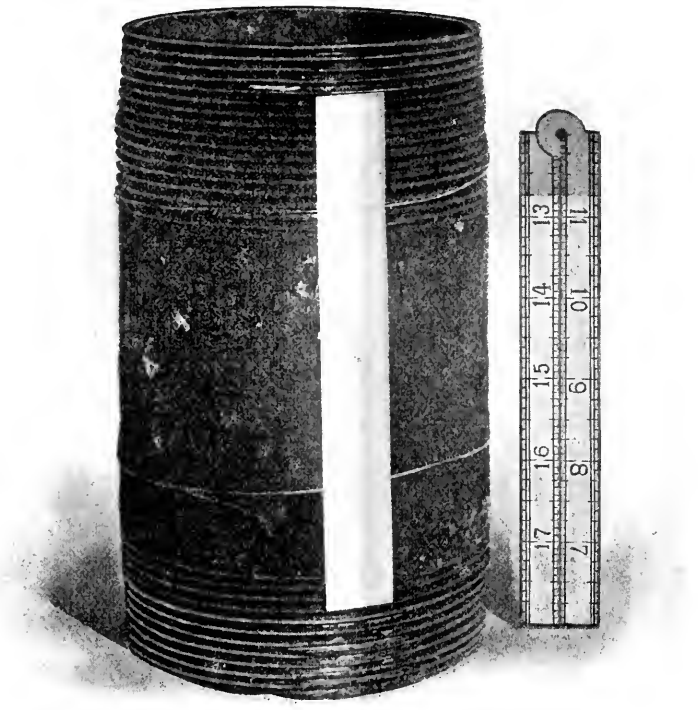
FIG. 7. — FOUR-INCH PIPE. THREAD WITHOUT SUFFICIENT TAPER; MADE UP ONLY FOUR THREADS.

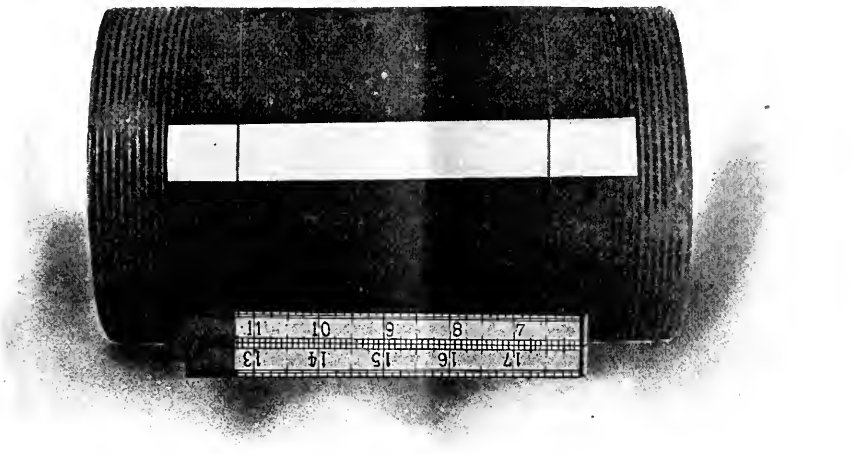
FIG. 8. — FIVE-INCH PIPE; STANDARD (OR NEARLY SO) AT ONE END, BUT NOT AT THE OTHER.

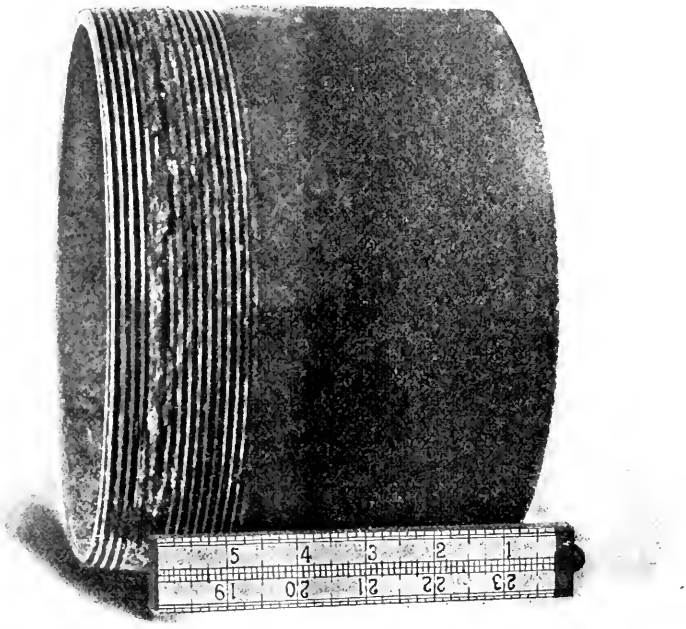
FIG. 9. — EIGHT-INCH PIPE, WHICH COULD BE MADE UP ONLY THREE THREADS.

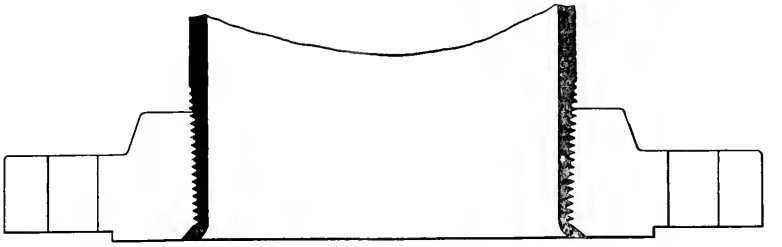
in fitting up piping, whether or not a joint is properly put together, and whether or not it is of the strength intended for standard fittings and pipe. Some of the specimens here illustrated show evidence that calking has been resorted to, in order to make them tight. This is all wrong, for if the joint is properly made up, calking will not be necessary. Calking to obtain tight work is proof of an imperfect joint. The *peening* of a pipe, however, is a very different matter, and the Hartford Steam Boiler Inspection and Insurance Company recommends the peening of pipe ends, when the piping is to be used in connection with pressures of over a hundred pounds. For this purpose a recess is formed in the face of the flange into which the pipe is screwed, and the end of the pipe (which is made a trifle long for this purpose) is peened solidly into this recess, as indicated in Fig. 10; the end of the pipe being afterwards faced off. The object of this peening, however, is not to make the pipe tight, but to increase its holding power in the flange; the pipe being supposed to be made up so that there is no leakage whatever, before the peening is begun.

FIG. 10. — ILLUSTRATING A PEENED PIPE.

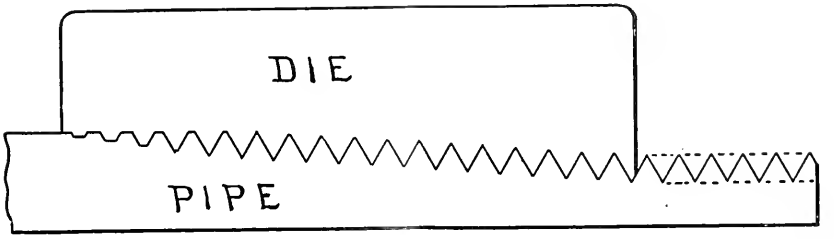
if the die used in threading the pipe is long enough and made with the standard taper; but when (as in the case now on the writer's desk) the thread on the pipe has been made long by running an ordinary die further up the pipe than usual, as is shown in Fig. 12, so that there is a straight part at the end, the pipe will necessarily "make up" into the flange or fitting somewhat as represented in Fig. 14. It is here supposed that the straight part of the pipe thread (indicated by the dotted line) is just of a size to fit the small end of the fitting perfectly. In that event, and assuming also that the taper on the pipe and the fitting is the

FIG. 12. — ILLUSTRATING THE EFFECT OF RUNNING THE DIE TOO FAR UP THE PIPE.

same, it is manifestly impossible for the threads in pipe and fitting to fit one another properly, anywhere except for a couple of threads at the small end of the fitting. Owing to the fact that the last threads on the pipe are imperfect (or should be), it is quite possible that one or two of the perfect threads at the large end of the fitting will touch the pipe in the manner indicated on the left of Fig. 14; but it is plain that a contact of this kind adds nothing to the holding power of the joint. In fact, in a case such as is shown in Fig. 14, the strength of the joint consists of nothing whatever save the few threads that bind where the straight part of the pipe thread makes into the smallest part of the fitting. The theory of the taper thread in pipe work is, that in making up the joints there

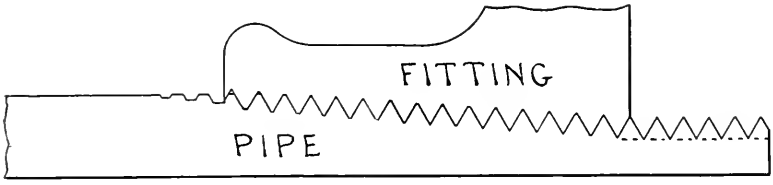
FIG. 13. — ILLUSTRATING THE PIPE PROJECTING THROUGH THE FITTING.

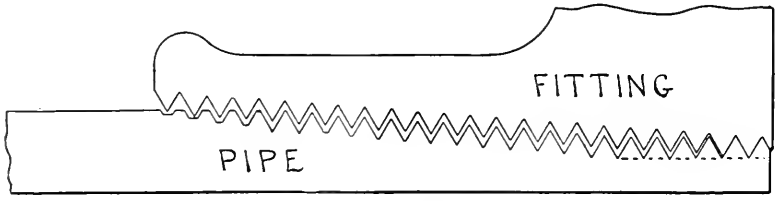
is just enough difference in the gauges of the fitting and the pipe to permit of the joint coming together so as to bring all the threads into good, compressive contact, throughout the whole length of the joint. In this manner a uniform strength and holding power is obtained, through every thread in the fitting; and with a heavy fitting and an extra length of *standard* thread, the joint becomes correspondingly stronger. But when the pipe thread is straight for a certain distance at the end, so that the condition of joint shown in Fig. 14 is inevitable, and only two or three or (at most) four threads are in good contact in the entire length of pipe, the conditions are very different. The joint is deficient in holding power, and the threads that are in contact, being insufficient to

FIG. 14. — ILLUSTRATING AN IMPERFECT PIPE JOINT.

hold the strain, are very likely to strip and withdraw, the load being thus thrown upon the next few threads; and these, since they will fit each other very poorly, are less strong than the original ones, and the joint presently fails, very likely with disastrous consequences. This action is greatly facilitated by the vibration which is universal in pipe lines and boiler connections, this vibration causing the threads to abrade and loosen. The dangers that we are pointing out are not imaginary in the least; for we have met with many cases of pipe failure, in the past few years, from the very causes here explained; and we cannot emphasize too strongly the fact that in threaded joints for high pressure work the greatest care should be taken to see that there is a uniform and standard taper, both in the

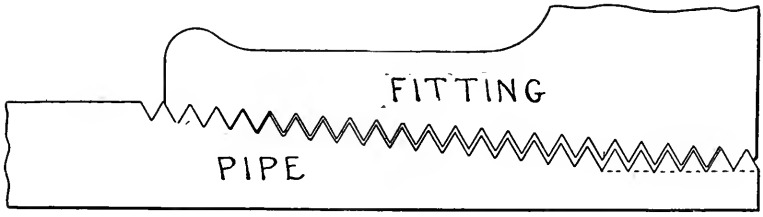
Sometimes pipe is threaded in such a manner that its end threads are straight for the reason illustrated in Fig. 12, while its tapered part makes a greater angle with the center line of the pipe than the standard calls for. In this case the pipe may fit the fitting at each end, while departing from it materially in the middle, as is illustrated in Fig. 15. A hold such as is shown in Fig. 15, while undoubtedly wretched and dangerous, is nevertheless slightly better than that shown in Fig. 14, since more of its threads are properly bottomed, and it is also more solid, and therefore less liable to suffer from vibration.

FIG. 15. — ILLUSTRATING AN IMPERFECT PIPE JOINT.

In conclusion, let us say that all pipe that is to be used in steam, water, and gas fitting should be of standard size, standard thickness, and standard thread, and should be round and straight. All fittings (unless made of malleable iron or steel, which would be preferable but more expensive) should be of heavy gray iron castings, with heavy beads, and with clean, full threads, tapped to standard gauge; and for high pressure service (100 pounds and over), the fittings should be extra heavy fittings, of the standard adopted by the American Society of Mechanical Engineers; the threads being cut actually and accurately by the Briggs standard in taper and gauge, but of the increased length required by the

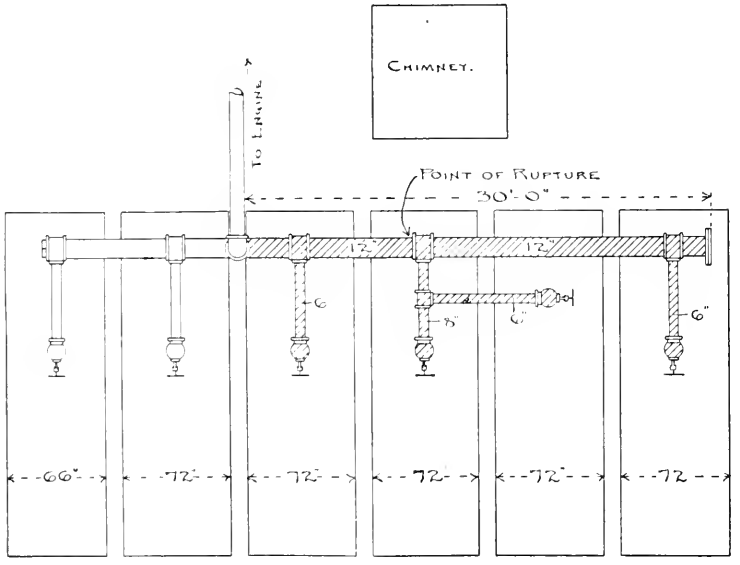
The steam pipe failure which is illustrated in the accompanying cuts occurred recently in the South, and it was thought to be well worth describing in THE LOCOMOTIVE, on account of the singular course that the broken pipe must have taken. The engravings themselves tell the story pretty well. The pipe which failed was a twelve-inch steam main, which received the output of six horizontal tubular boilers. The initial rupture occurred at a cast-iron tee,

FIG. 1. — PLAN VIEW OF BOILER PLANT.

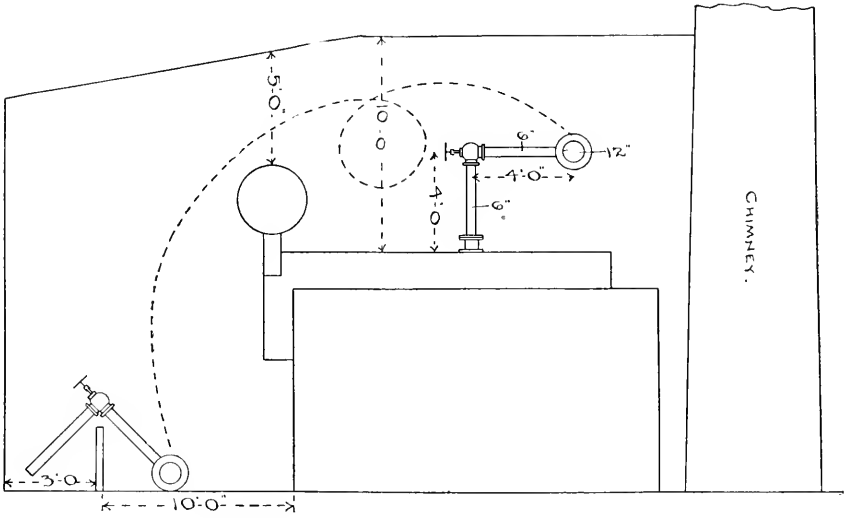
boilers, passing, in its course, between the smoke flue and the roof of the boiler house. As will be seen from Fig. 2, the space between the flue and the roof is only five feet high; and the singular fact about the accident is, that the broken main, together with its attached risers, passed through this space without hitting

FIG. 2. — ELEVATION OF BOILER PLANT.

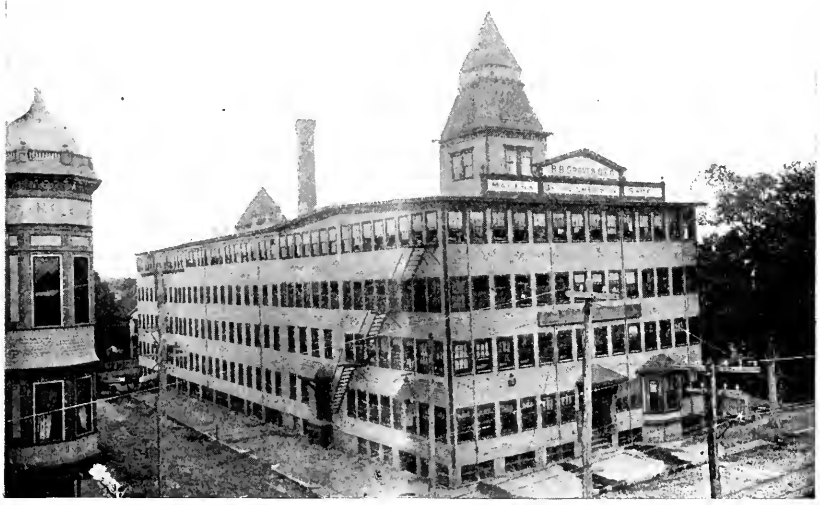
At a few minutes before eight o'clock, on the morning of March 20, 1905, a terrible boiler explosion occurred at Brockton, Mass., in the factory of R. B. Grover & Company, manufacturers of the Emerson shoe. The explosion and its effects were awful, beyond all description. The entire country was profoundly shocked, and Brockton itself was overwhelmed with horror and grief.

FIG. 1.—THE R. B. GROVER COMPANY PLANT BEFORE THE EXPLOSION.

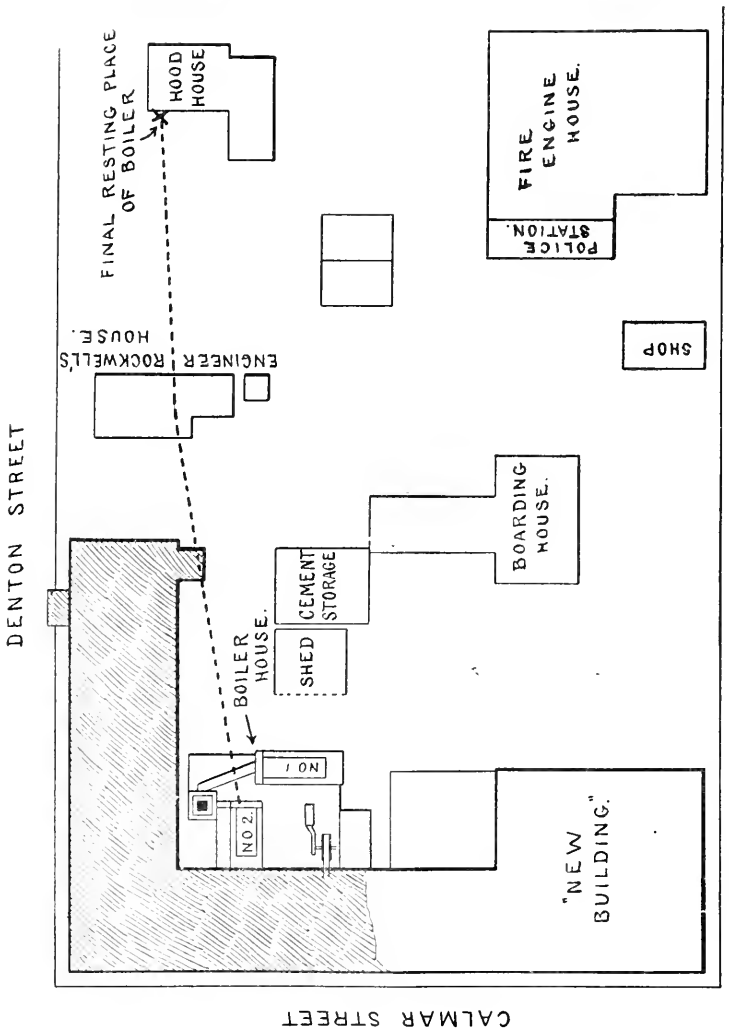
FIG. 2.—PLAN OF THE BUILDINGS.
The dotted line shows the course of the boiler, and the shaded area shows the part of the main building that was immediately thrown down by the explosion.

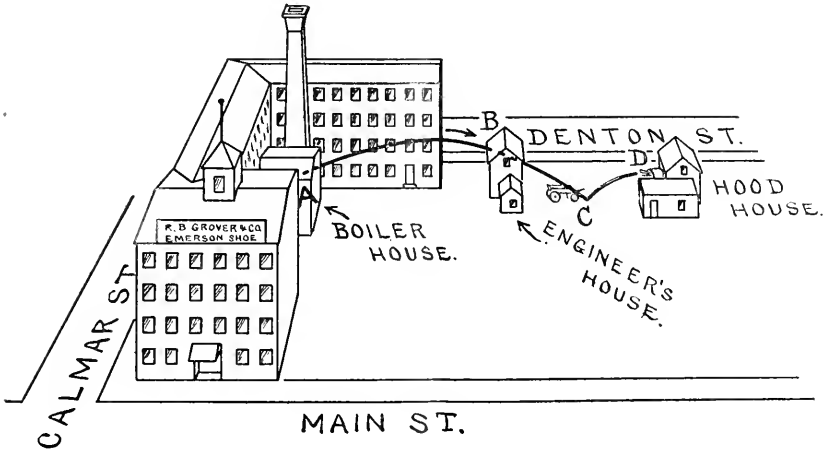
FIG. 3.—PERSPECTIVE VIEW OF THE BUILDINGS.
The curved line, A B C D, shows the course of the boiler.

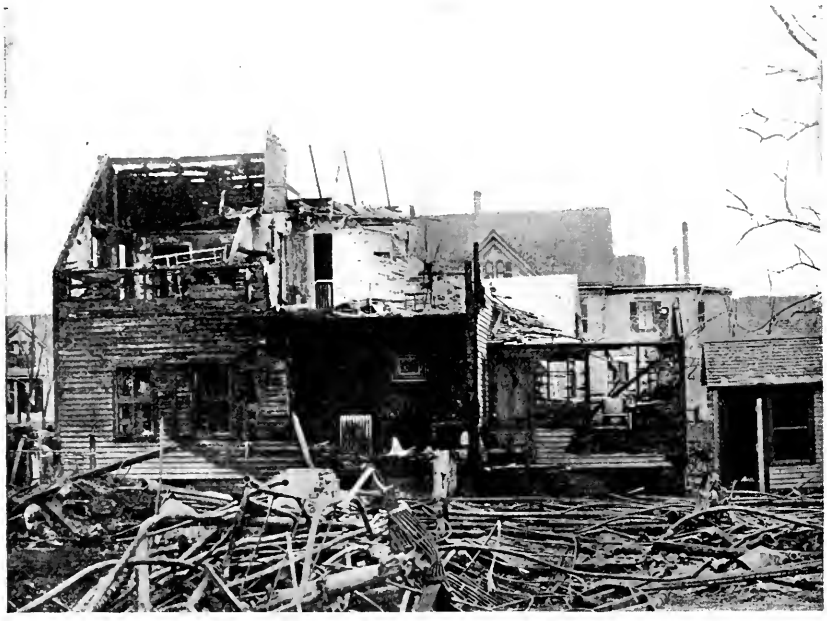
FIG. 7.—ENGINEER DAVID W. ROCKWELL'S HOUSE VIEWED FROM THE FACTORY SIDE.

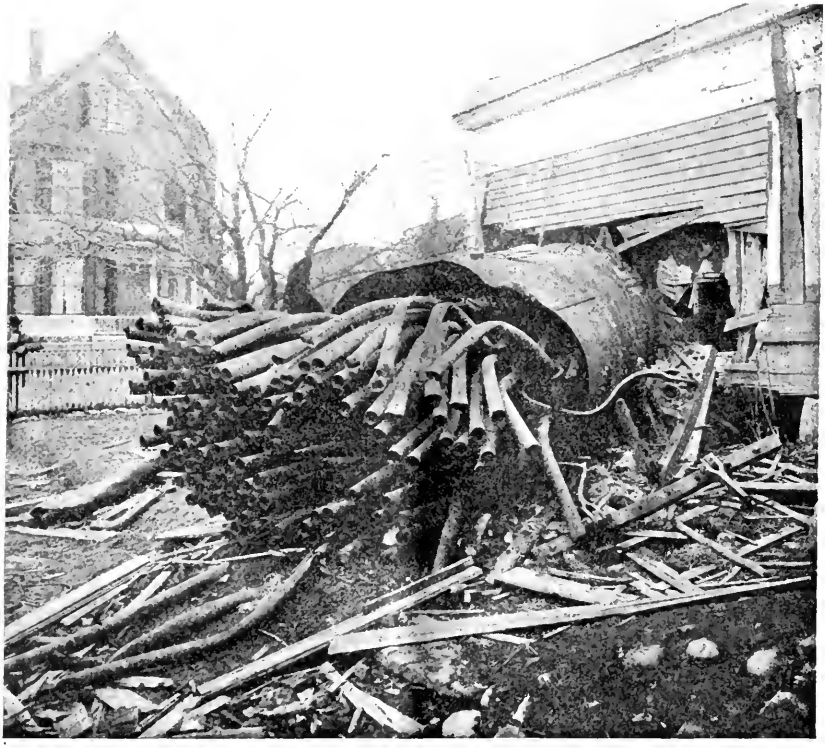
FIG. 9.—SHOWING THE BOILER IN ITS FINAL POSITION, AGAINST THE HOOD HOUSE.

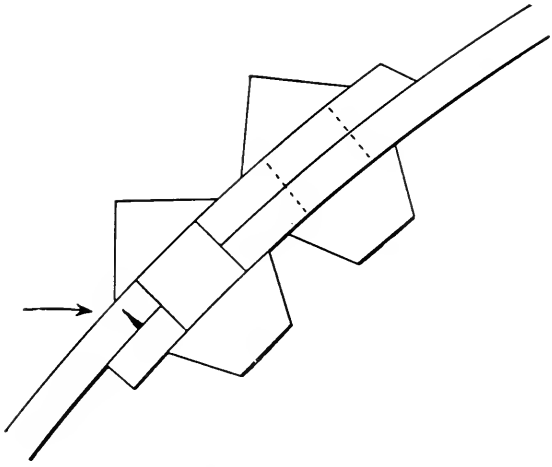
FIG. 11.— ILLUSTRATING THE HIDDEN CRACK WHICH CAUSED THE EXPLOSION. This cut is drawn to scale, one-half the actual size. For a more extended account of lap-joint cracks, see the separate article on this subject, in the present issue.

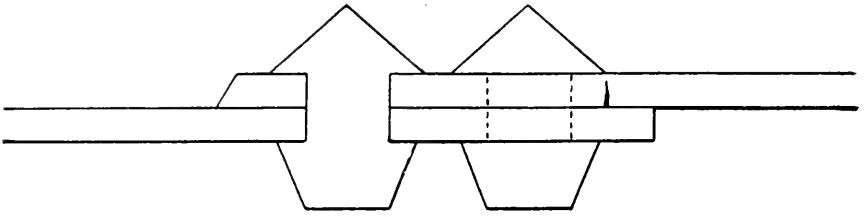
FIG. 1. — A LAP-JOINT CRACK UNDER THE OUTER EDGE OF THE RIVET HEADS.

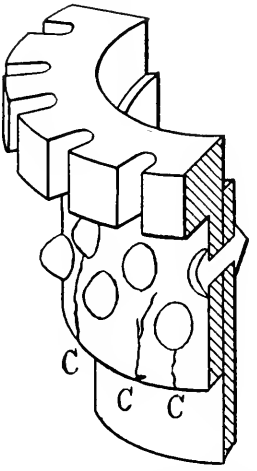
FIG. 6. — SHOWING "HUB CRACKS."
